**Flood Control Project Maintenance
Levee Inspections**
LMA District Cover Sheet
Spring 2019 Levee Inspection Results

Madera County FCWCA

Spring 2019 Levee Inspection Results

Waterway			Bank	Unit Miles
Unit No. 01 Ash Slough			Right	2.37
	Spring (March - May)	Summer (June - August)	(September - November) Fall	Winter (December - February)
Unit Maintenance Rating (Fall Only)				
Date of Inspection	5/9/2019 - 5/9/2019			
DWR Inspector	Corey Fujitani			
Accompanied By	Dario Dominguez Madera County

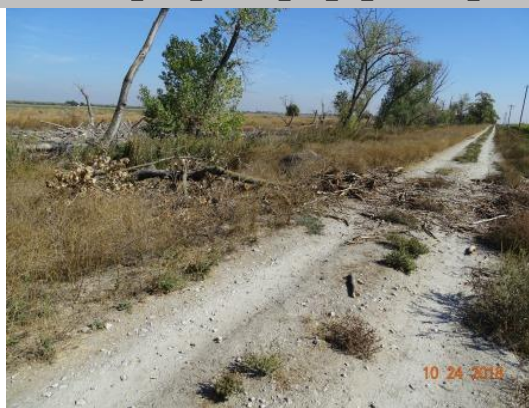
Photo 1 of 1 : SP_2019_NA0011_145_31_20190307_00024.jpg

LM Start	0.75	Rating **	M	Issue No.	31
LM End	0.75	Issue Type +	Ma	Location *	CR
Category	Earthen Levee			GPS Latitude/Longitude	
				Start	End
Item	Encroachments			36.995582 °	36.995582 °
				-120.360028 °	-120.360028 °
DWR ID	DWR_NA0011_04_f_2018_31				
Comment Code					
TR : Tree or limb					
Inspector Comment

Tree branches strewn across levee crown and both shoulders. (Fall 2018)

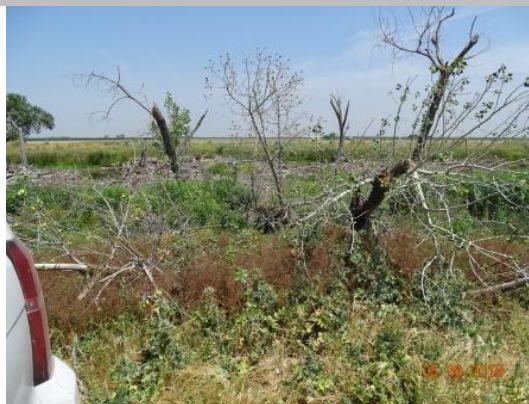
Photo 1 of 1 : SP_2019_NA0011_145_6_20190514_00033.jpg

LM Start	0.78	Rating **	U	Issue No.	6
LM End	0.78	Issue Type +	Ma	Location *	WS
Category	Earthen Levee			GPS Latitude/Longitude	
				Start	End
Item	Encroachments			36.995582 °	36.995582 °
				-120.359451 °	-120.359451 °
DWR ID	DWR_NA0011_04_s_2019_6				
Comment Code					
TR : Tree or limb					
Inspector Comment

View of fallen tree on waterside slope. (Spring 2019)

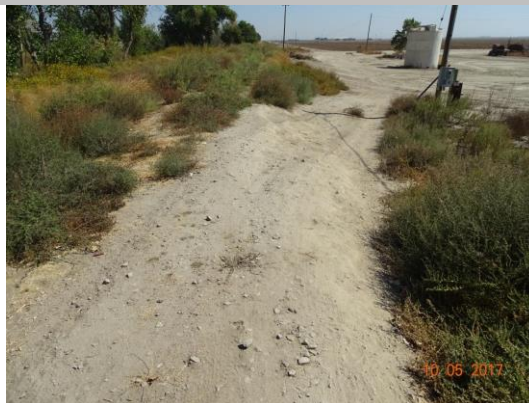
Photo 1 of 2 : SP_2019_NA0011_145_13_20190307_00011.jpg

LM Start	0.94	Rating **	M	Issue No.	13
LM End	0.94	Issue Type +	En	Location *	LS
Category	Earthen Levee			GPS Latitude/Longitude	
				Start	End
Item	Encroachments			36.995571 °	36.995571 °
				-120.356609 °	-120.356609 °
DWR ID	DWR_NA0011_04_f_2017_13				
Comment Code					
RA : Ramp					
Inspector Comment					
There is no permit for the ramp on the landside slope.

Restore levee slope.

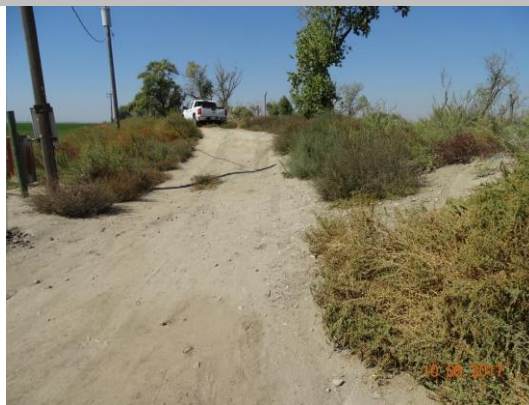
Photo 2 of 2 : SP_2019_NA0011_145_13_20190307_00012.jpg

LM Start	0.94	Rating **	M	Issue No.	13 (cont)
LM End	0.94	Issue Type +	En	Location *	LS

Unpermitted ramp on LS slope.

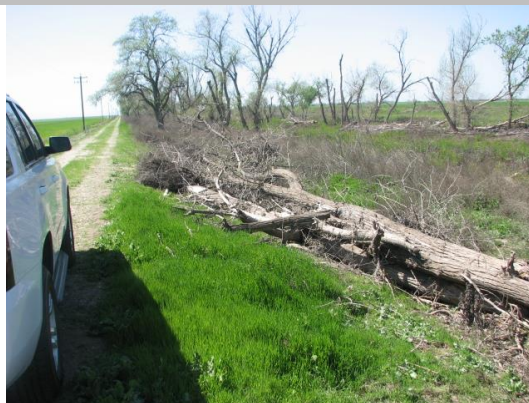
Photo 1 of 1 : SP_2019_NA0011_145_14_20190307_00013.jpg

LM Start	0.94	Rating **	M	Issue No.	14
LM End	0.94	Issue Type +	En	Location *	WS
Category	Earthen Levee			GPS Latitude/Longitude	
				Start	End
Item	Encroachments			36.995573 °	36.995573 °
				-120.356601 °	-120.356601 °
DWR ID	DWR_NA0011_04_f_2017_14				
Comment Code					
TR : Tree or limb					
Inspector Comment					
Remove the downed tree from the waterside slope.

Looking upstream at fallen tree on waterward slope. (Spring 2018)

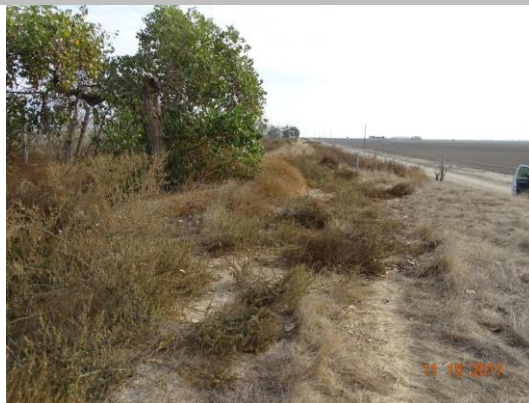
Photo 1 of 1 : SP_2019_NA0011_145_12_20190307_00010.jpg

LM Start	1.01	Rating **	U	Issue No.	12
LM End	1.01	Issue Type +	Ma	Location *	WS
Category	Earthen Levee			GPS Latitude/Longitude	
				Start	End
Item	Trim / Thin Trees			36.995537 °	36.995537 °
				-120.355261 °	-120.355261 °
DWR ID	DWR_NA0011_04_f_2017_12				
Comment Code					
T1 : Trim trees to at least five feet above ground level.					
Inspector Comment					
Branches from waterside tree are blocking visibility of waterside slope and crown. Levee crown is nearly impassible.

Trim trees to at least 5' above levee slope and 12' above levee crown to allow inspection and access.

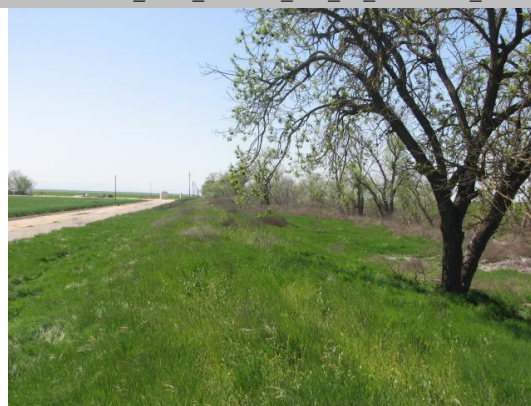
Photo 1 of 1 : SP_2019_NA0011_145_10_20190307_00007.jpg

LM Start	1.19	Rating **	U	Issue No.	10
LM End	1.19	Issue Type +	Ma	Location *	WS
Category	Earthen Levee			GPS Latitude/Longitude	
				Start	End
Item	Trim / Thin Trees			36.995566 °	36.995566 °
				-120.352038 °	-120.352038 °
DWR ID	DWR_NA0011_04_f_2017_10				
Comment Code					
T4 : Trim trees over roadway to at least 12 feet above ground level.					
Inspector Comment

Looking upstream at tree on waterward slope. (Spring 2018)

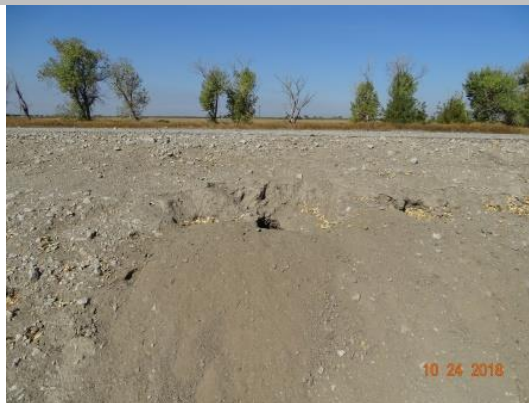
Photo 1 of 2 : SP_2019_NA0011_145_11_20190307_00008.jpg

LM Start	1.50	Rating **	U	Issue No.	11
LM End	2.28	Issue Type +	Ma	Location *	LS
Category	Earthen Levee			GPS Latitude/Longitude	
				Start	End
Item	Animal Control			36.995590 °	37.003740 °
				-120.346406 °	-120.336877 °
DWR ID	DWR_NA0011_04_f_2016_11				
Comment Code					
A1 : Exterminate rodents and backfill and compact or grout burrows.					
Inspector Comment					
Exterminate the rodents and backfill and compact the burrows or grout the burrows in this area.

Large rodent holes along this section. (Fall 2018)

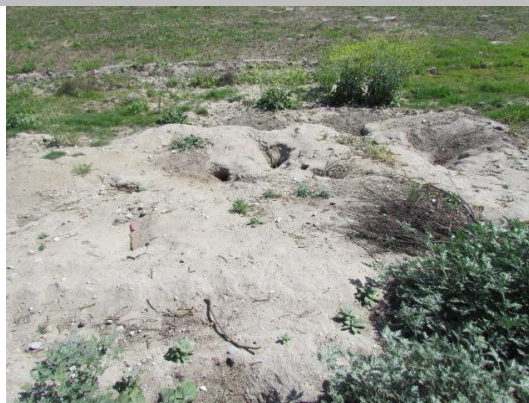
Photo 2 of 2 : SP_2019_NA0011_145_11_20190307_00009.jpg

LM Start	1.50	Rating **	U	Issue No.	11 (cont)
LM End	2.28	Issue Type +	Ma	Location *	LS

Looking upstream at rodent activity on landward slope and toe.

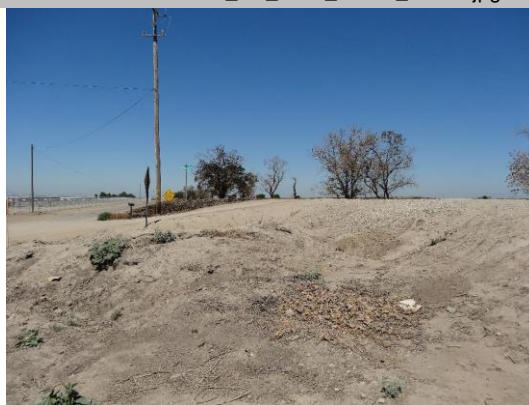
Photo 1 of 3 : UCIP_SP_2019_53154_75760.jpg

Comment Code					
Inspector Comment					
FS_ID:53154 DS_ID:25469 EP_NO: N/A Repair Type: Urgent Crossing Status: Found UCIP Comments: 10/31/2018 Same as last inspection with the exception of the size of the sink hole. Sink hole on LS slope has increased. Levee at this crossing is composed of highly erodible material. Need to coordinate with the pipe owner to determine repair status. Crossing remains Urgent due to the large sink hole present on the LS. (O. Magana - DWR UCIP) 07/14/2016 New entry added--pipe failure. Sink hole present on LS slope. Concrete headwall collapse visible on LS slope. Pipe buried on both WS and LS. (DWR UCIP - omagana) FIELD_STRUCT_DESC: 24-inch (estimate measurement based on flap gate frame) gravity drainage pipe of an unknown material through the levee, approximately 5 feet below the crown. Concrete headwall on the landside (LS). Corrugated metal pipe (CMP) at the LS toe. Sluice gate on the waterside (WS). This crossing was field discovered. FS Date: 10/31/2018 10:19:00 AM

View of LS slope.

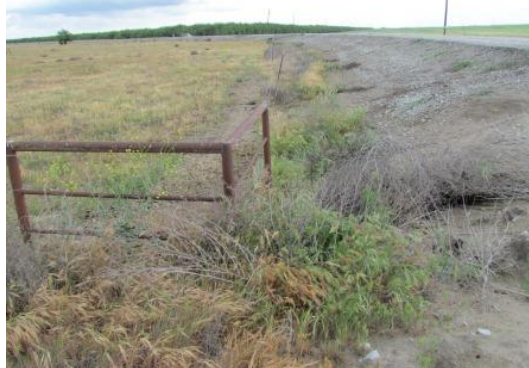
Photo 1 of 1 : SP_2019_NA0011_145_56_20190307_00026.jpg

LM Start	1.51	Rating **	M	Issue No.	56
LM End	2.28	Issue Type +	En	Location *	WS
Category	Earthen Levee			GPS Latitude/Longitude	
				Start	End
Item	Encroachments			36.995615 °	37.003441 °
				-120.346296 °	-121.337349 °
DWR ID	DWR_NA0011_04_s_2012_56				
Comment Code					
FE : Fence					
Inspector Comment

Fence within the 10-foot of levee toe. This encroachment was recorded on 11-01-2012. Photo was taken 4-24-2014.

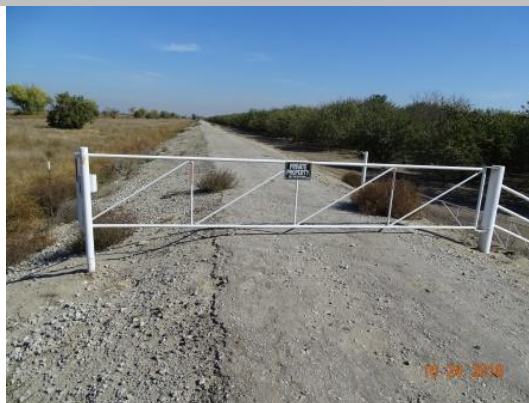
Photo 1 of 2 : SP_2019_NA0011_145_17_20190307_00016.jpg

LM Start	1.60	Rating **	U	Issue No.	17
LM End	1.60	Issue Type +	En	Location *	CR
Category	Earthen Levee			GPS Latitude/Longitude	
				Start	End
Item	Encroachments			36.996212 °	36.996212 °
				-120.344756 °	-120.344756 °
DWR ID	DWR_NA0011_04_f_2018_17				
Comment Code					
FE : Fence					
Inspector Comment					
Gate with combo lock only. LMA is trying to obtain the combination from the landowner.

Gate blocking access to levee. (Fall 2018)

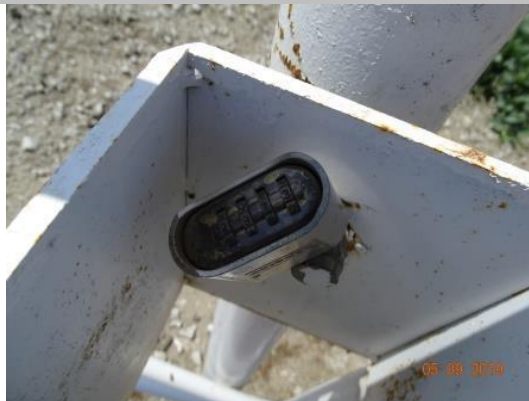
Photo 2 of 2 : SP_2019_NA0011_145_17_20190514_00034.jpg

LM Start	1.60	Rating **	U	Issue No.	17 (cont)
LM End	1.60	Issue Type +	En	Location *	CR

View of combo lock on gate. (Spring 2019)

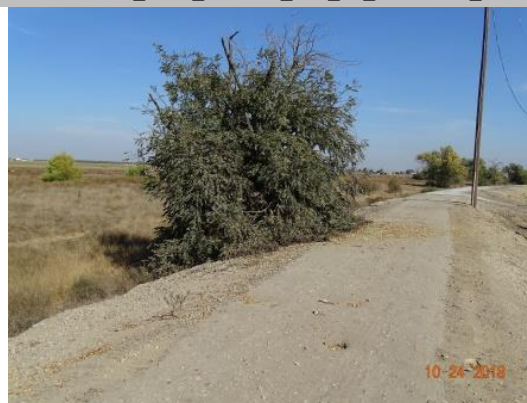
Photo 1 of 1 : SP_2019_NA0011_145_27_20190307_00021.jpg

LM Start	2.22	Rating **	M	Issue No.	27
LM End	2.22	Issue Type +	Ma	Location *	WS
Category	Earthen Levee			GPS Latitude/Longitude	
				Start	End
Item	Trim / Thin Trees			37.003160 °	37.003160 °
				-120.337747 °	-120.337747 °
DWR ID	DWR_NA0011_04_f_2018_27				
Comment Code					
T1 : Trim trees to at least five feet above ground level.					
Inspector Comment					
Trim tree back away from crown and at least 5 feet above the levee slope.

Trim tree on waterside shoulder. (Fall 2018)

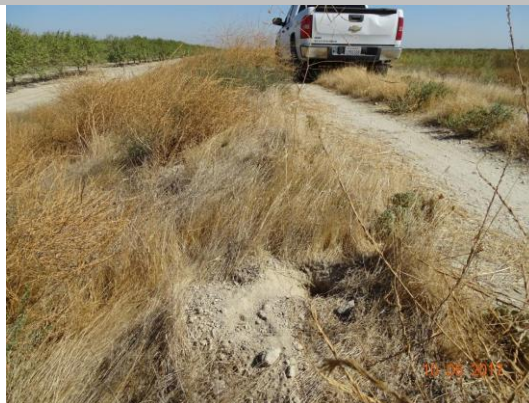
Photo 1 of 1 : SP_2019_NA0011_146_14_20190307_00007.jpg

LM Start	0.00	Rating **	M	Issue No.	14
LM End	4.05	Issue Type +	Ma	Location *	LS
Category	Earthen Levee			GPS Latitude/Longitude	
				Start	End
Item	Animal Control			36.978520 °	36.968168 °
				-120.368567 °	-120.301035 °
DWR ID	DWR_NA0011_05_f_2016_14				
Comment Code					
A1 : Exterminate rodents and backfill and compact or grout burrows.					
Inspector Comment					
Exterminate the rodents along the landside slope and toe throughout the area to levee mile 4.05. Bait stations are needed in infested areas.

Rodent activity on landside slope.

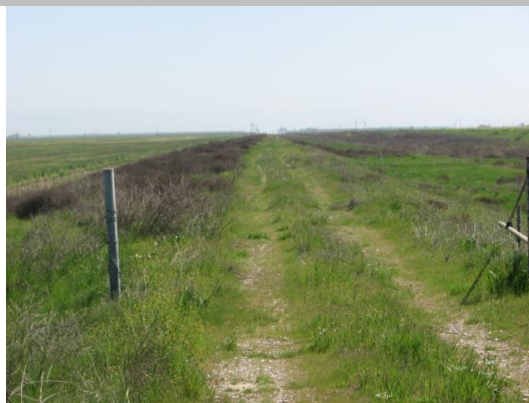
Photo 1 of 1 : SP_2019_NA0011_146_13_20190307_00006.jpg

LM Start	0.00	Rating **	M	Issue No.	13
LM End	4.05	Issue Type +	Ma	Location *	CR
Category	Earthen Levee			GPS Latitude/Longitude	
				Start	End
Item	Crown Surface / Depressions / Rutting			36.978548 °	36.968165 °
				-120.368454 °	-120.301151 °
DWR ID	DWR_NA0011_05_s_2012_13				
Comment Code					
C1 : Add appropriate material and re-grade the levee to bring the crown above the design elevation.					
Inspector Comment					
Regrade the crown for proper drainage. And add appropriate gravel or road base.

Looking downstream at levee crown from 0.00. (Spring 2018)

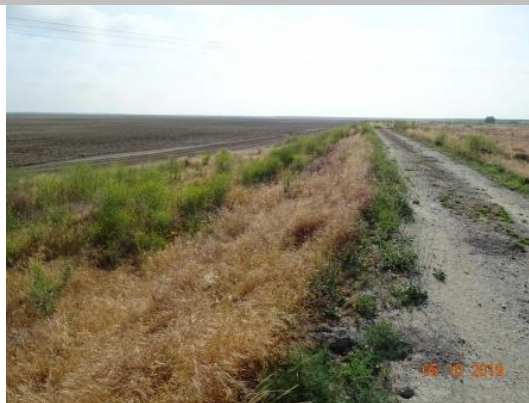
Photo 1 of 1 : SP_2019_NA0011_146_20_20190514_00034.jpg

LM Start	0.01	Rating **	U	Issue No.	20
LM End	4.06	Issue Type +	Ma	Location *	LS
Category	Earthen Levee			GPS Latitude/Longitude	
				Start	End
Item	Vegetation			36.978551 °	36.968173 °
				-120.368390 °	-120.300901 °
DWR ID	DWR_NA0011_05_s_2019_20				
Comment Code					
V1 : Control annual grass and weeds on the levee slopes and easements.					
Inspector Comment

View of landside slope looking upstream. (Spring 2019)

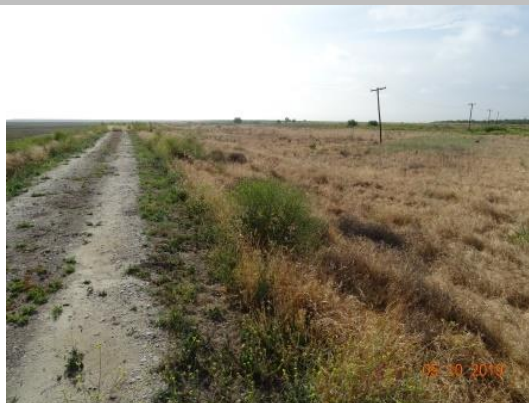
Photo 1 of 1 : SP_2019_NA0011_146_40_20190514_00033.jpg

LM Start	0.01	Rating **	U	Issue No.	40
LM End	4.06	Issue Type +	Ma	Location *	WS
Category	Earthen Levee			GPS Latitude/Longitude	
				Start	End
Item	Vegetation			36.978551 °	36.968173 °
				-120.368390 °	-120.300901 °
DWR ID	DWR_NA0011_05_s_2019_40				
Comment Code					
V1 : Control annual grass and weeds on the levee slopes and easements.					
Inspector Comment

View of waterside slope looking upstream. (Spring 2019)

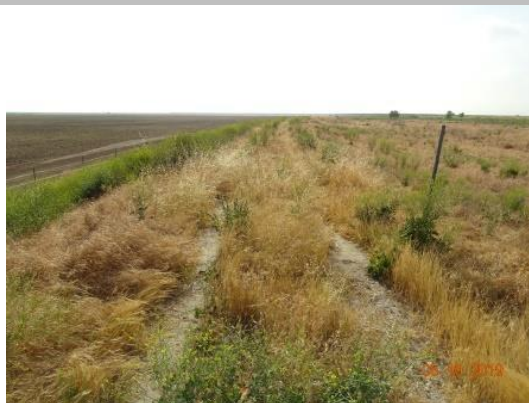
Photo 1 of 1 : SP_2019_NA0011_146_42_20190514_00032.jpg

LM Start	0.04	Rating **	U	Issue No.	42
LM End	4.06	Issue Type +	Ma	Location *	CR
Category	Earthen Levee			GPS Latitude/Longitude	
				Start	End
Item	Vegetation			36.978511 °	36.968173 °
				-120.367758 °	-120.300901 °
DWR ID	DWR_NA0011_05_s_2019_42				
Comment Code					
V9 : Keep the crown roadway free of vegetation.					
Inspector Comment

View of levee crown looking downstream. (Spring 2019)

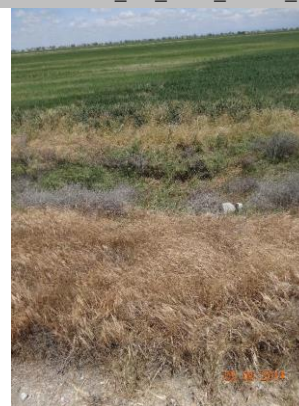
Photo 3 of 3 : UCIP_SP_2019_52833_64565.jpg

Comment Code						
Inspector Comment						
FS_ID:52833						
DS_ID:21520						
EP_NO: N/A						
Repair Type: Non-Urgent						
Crossing Status: Found						
UCIP Comments: 05/06/2014 Need to contact owner. Dense vegetation limits the inspector's visibility to identify signs of pipe failure (leaks) along the landward slope. Recommend removing vegetation along pipe alignment to conduct proper inspection of structure. (DWR UCIP - O. Magana)						
FIELD_STRUCT_DESC: 36-inch corrugated metal gravity drainage pipe through the levee, 10.8 feet below the crown. Headwall and wing wall on each end. Flap gate on the waterside (WS) end. [Additional Reference(s): DWR Levee Log, 2005].						
FS Date: 5/6/2014

View of landward side.

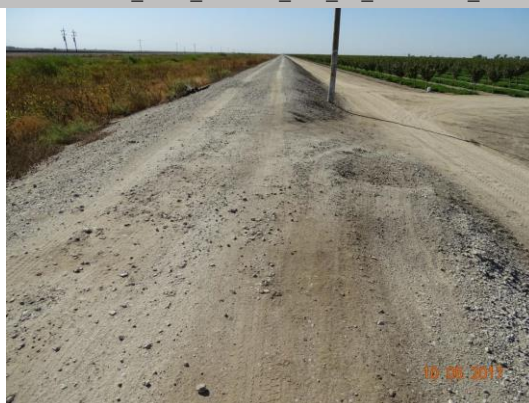
Photo 1 of 1 : SP_2019_NA0011_146_18_20190307_00010.jpg

LM Start	5.56	Rating **	M	Issue No.	18
LM End	5.56	Issue Type +	Ma	Location *	LS
Category	Earthen Levee			GPS Latitude/Longitude	
				Start	End
Item	Slope Stability			36.968210 °	36.968210 °
				-120.273729 °	-120.273729 °
DWR ID	DWR_NA0011_05_f_2017_18				
Comment Code					
S3 : Repair the levee slope damaged by vehicle traffic and prevent access where possible.					
Inspector Comment					
Repair damage from vehicle traffic on slope and shoulder.

Repair damage from vehicle traffic on slope and shoulder.

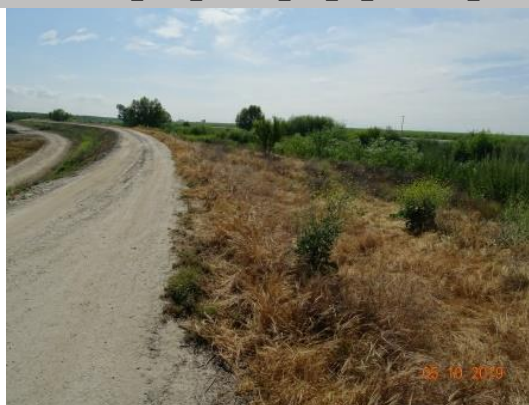
Photo 1 of 1 : SP_2019_NA0011_146_47_20190514_00039.jpg

LM Start	6.58	Rating **	U	Issue No.	47
LM End	7.63	Issue Type +	Ma	Location *	WS
Category	Earthen Levee			GPS Latitude/Longitude	
				Start	End
Item	Vegetation			36.968515 °	36.969551 °
				-120.255374 °	-120.236609 °
DWR ID	DWR_NA0011_05_s_2019_47				
Comment Code					
V1 : Control annual grass and weeds on the levee slopes and easements.					
Inspector Comment

View of vegetation on waterside slope looking upstream. (Spring 2019)

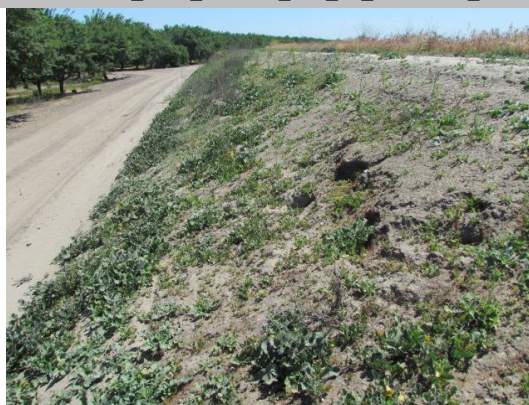
Photo 1 of 1 : SP_2019_NA0011_146_28_20190307_00016.jpg

LM Start	6.75	Rating **	U	Issue No.	28
LM End	6.95	Issue Type +	Ma	Location *	LS
Category	Earthen Levee			GPS Latitude/Longitude	
				Start	End
Item	Animal Control			36.969200 °	36.969507 °
				-120.252462 °	-120.248893 °
DWR ID	DWR_NA0011_05_f_2016_28				
Comment Code					
A1 : Exterminate rodents and backfill and compact or grout burrows.					
Inspector Comment					
Exterminate the rodents in the area listed and place bait stations along the shoulder and or slope.

Fresno River landside levee slope levee mile 6.75-6.95.

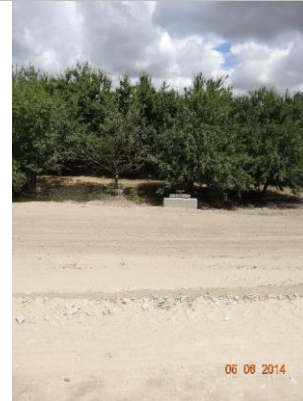
Photo 3 of 3 : UCIP_SP_2019_52859_69713.jpg

Comment Code						
Inspector Comment						
FS_ID:52859 DS_ID:21527 EP_NO: N/A Repair Type: Non-Urgent Crossing Status: Found UCIP Comments: 05/06/2014 Need to contact owner. Dense vegetation limits the inspector's visibility to identify signs of pipe failure (leaks) along the waterward slope. Recommend removing vegetation along pipe alignment to conduct proper inspection of structure and appurtenances. Slide gate buried on landward side. Recommend clearing sediment deposit on landward side. (DWR UCIP - O. Magana) FIELD_STRUCT_DESC: 30-inch corrugated metal gravity drainage pipe through the levee, 9.4 feet below the crown. Headwall and wing wall on each end. Flap gate on the waterside (WS) end. [Additional Reference(s): DWR Levee Log, 2005]. FS Date: 5/6/2014

View of landward side.

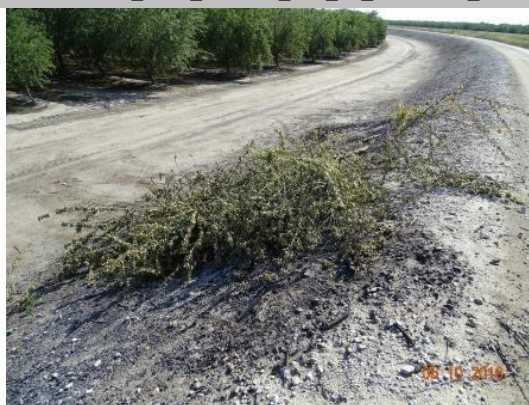
Photo 1 of 2 : SP_2019_NA0011_146_30_20190514_00040.jpg

LM Start	7.63	Rating **	M	Issue No.	30
LM End	7.63	Issue Type +	En	Location *	LS
Category	Earthen Levee			GPS Latitude/Longitude	
				Start	End
Item	Encroachments			36.969550 °	36.969550 °
				-120.236670 °	-120.236670 °
DWR ID	DWR_NA0011_05_f_2018_30				
Comment Code					
PR : Prunings					
Inspector Comment					
Prunings left on landside slope.

Pruning pile starting to accumulate on landside slope. (Spring 2019)

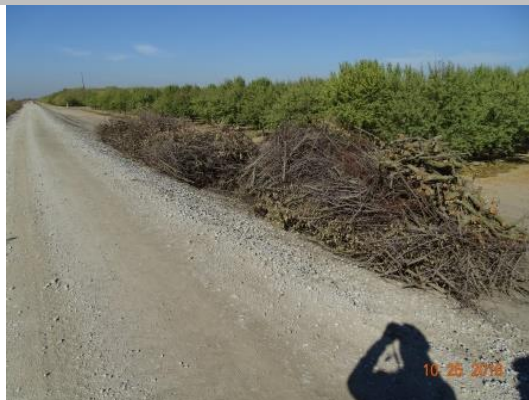
Photo 2 of 2 : SP_2019_NA0011_146_30_20190307_00017.jpg

Pruning piles on landside slope. (Fall 2018)

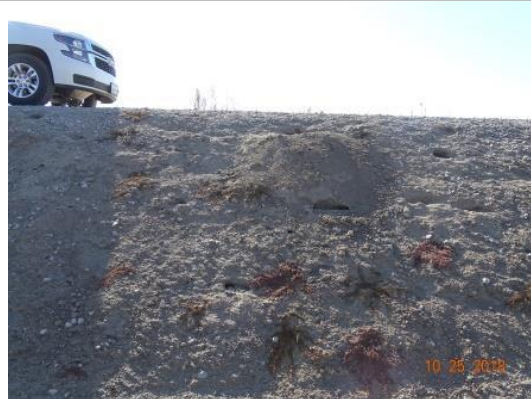
Photo 1 of 1 : SP_2019_NA0011_146_12_20190307_00005.jpg

LM Start	7.99	Rating **	U	Issue No.	12
LM End	8.01	Issue Type +	Ma	Location *	LS
Category	Earthen Levee			GPS Latitude/Longitude	
				Start	End
Item	Animal Control			36.972121 °	36.972186 °
				-120.230994 °	-120.230772 °
DWR ID	DWR_NA0011_05_f_2018_12				
Comment Code					
A3 : No rodents visible, but rodent burrows visible; need to backfill and compact or grout burrows.					
Inspector Comment					
Large rodent burrow observed in this section.

Rodent activity on landside slope. (Fall 2018)

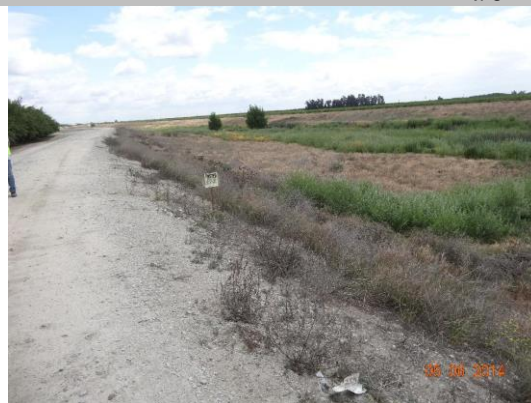
Photo 1 of 3 : UCIP_SP_2019_52863_69719.jpg

Comment Code					
Inspector Comment					
FS_ID:52863 DS_ID:21528 EP_NO: N/A Repair Type: Non-Urgent Crossing Status: Found UCIP Comments: 05/06/2014 Need to contact owner. Dense vegetation limits the inspector's visibility to identify signs of pipe failure (leaks) along the waterward slope. Recommend removing vegetation along pipe alignment to conduct proper inspection of structure and appurtenances. (DWR UCIP - O. Magana) FIELD_STRUCT_DESC: 30-inch corrugated metal gravity drainage pipe through the levee, 8.3 feet below the crown. Headwall and wing wall on each end. Flap gate on the waterside (WS) end. [Additional Reference(s): DWR Levee Log, 2005]. FS Date: 5/6/2014

View of waterward side.

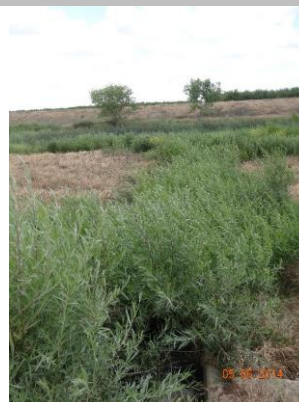
Photo 3 of 3 : UCIP_SP_2019_52863_69720.jpg

Comment Code						
Inspector Comment						
FS_ID:52863						
DS_ID:21528						
EP_NO: N/A						
Repair Type: Non-Urgent						
Crossing Status: Found						
UCIP Comments: 05/06/2014 Need to contact owner. Dense vegetation limits the inspector's visibility to identify signs of pipe failure (leaks) along the waterward slope. Recommend removing vegetation along pipe alignment to conduct proper inspection of structure and appurtenances. (DWR UCIP - O. Magana)						
FIELD_STRUCT_DESC: 30-inch corrugated metal gravity drainage pipe through the levee, 8.3 feet below the crown. Headwall and wing wall on each end. Flap gate on the waterside (WS) end. [Additional Reference(s): DWR Levee Log, 2005].						
FS Date: 5/6/2014

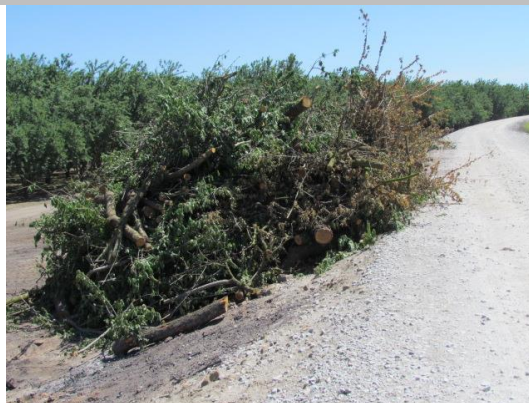
Photo 1 of 1 : SP_2019_NA0011_146_35_20190307_00019.jpg

LM Start	8.36	Rating **	U	Issue No.	35
LM End	8.41	Issue Type +	En	Location *	LS
Category	Earthen Levee			GPS Latitude/Longitude	
				Start	End
Item	Encroachments			36.972937 °	36.972947 °
				-120.224457 °	-120.223607 °
DWR ID	DWR_NA0011_05_f_2015_35				
Comment Code					
PR : Prunings					
Inspector Comment					
Move burnpile away from levee as it provides cover for burrowing rodents.

Burn pile on LS slope.

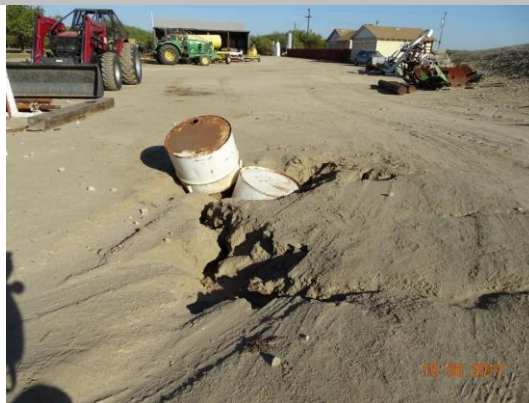
Photo 1 of 2 : SP_2019_NA0011_146_25_20190307_00013.jpg

LM Start	8.53	Rating **	M	Issue No.	25
LM End	8.53	Issue Type +	En	Location *	LS
Category	Earthen Levee			GPS Latitude/Longitude	
				Start	End
Item	Encroachments			36.972643 °	36.972643 °
				-120.221488 °	-120.221488 °
DWR ID	DWR_NA0011_05_f_2017_25				
Comment Code					
PI : Pipe					
Inspector Comment					
Possible sinkhole 10 feet from landside levee toe. 6 ft long by 1-2 ft wide by 5.5 ft deep. 55gal drum halves were placed in hole for safety. Met with Rick Cosyns (MID 559-232-0227) on site. Speculated that it was likely an underground pipe with collapsed backfill.

Possible sinkhole 10 feet from landside levee toe. 6 ft long by 1-2 ft wide by 5.5 ft deep. White 55gal drum halves were placed in hole for safety.

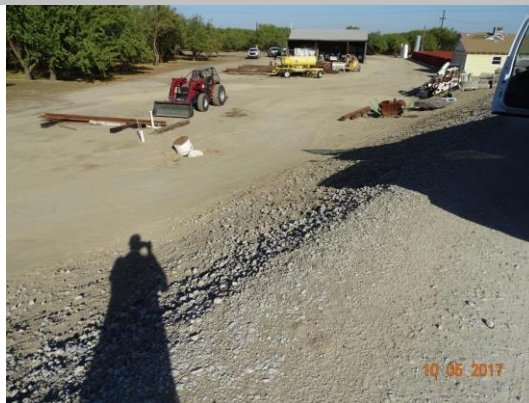
Photo 2 of 2 : SP_2019_NA0011_146_25_20190307_00014.jpg

Possible sinkhole 10 feet from landside levee toe. 6 ft long by 1-2 ft wide by 5.5 ft deep. White 55gal drum halves were placed in hole for safety.

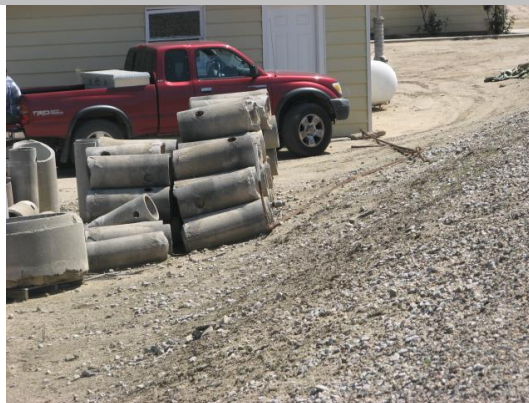
Photo 1 of 1 : SP_2019_NA0011_146_26_20190307_00015.jpg

LM Start	8.53	Rating **	M	Issue No.	26
LM End	8.53	Issue Type +	En	Location *	LS
Category	Earthen Levee			GPS Latitude/Longitude	
				Start	End
Item	Encroachments			36.972616 °	36.972606 °
				-120.221415 °	-120.221389 °
DWR ID	DWR_NA0011_05_f_2017_26				
Comment Code					
EQ : Equipment					
Inspector Comment					
Concrete pipes at landward toe.

Looking upstream at concrete pipes stored at landward toe. (Spring 2018)

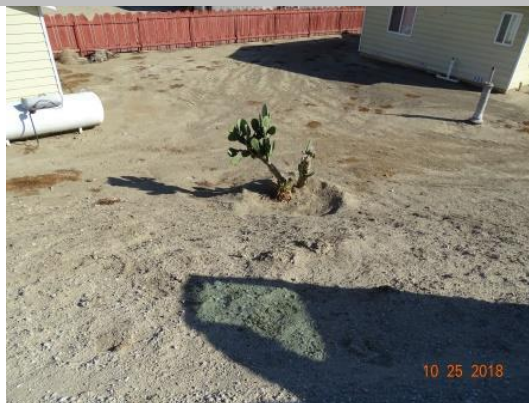
Photo 1 of 1 : SP_2019_NA0011_146_11_20190307_00004.jpg

LM Start	8.56	Rating **	U	Issue No.	11
LM End	8.56	Issue Type +	En	Location *	LS
Category	Earthen Levee			GPS Latitude/Longitude	
				Start	End
Item	Vegetation			36.972384 °	36.972384 °
				-120.220907 °	-120.220907 °
DWR ID	DWR_NA0011_05_f_2018_11				
Comment Code					
V6 : Landscaping					
Inspector Comment					
cactus planted on landside toe.

Cactus on landside toe. (Fall 2018)

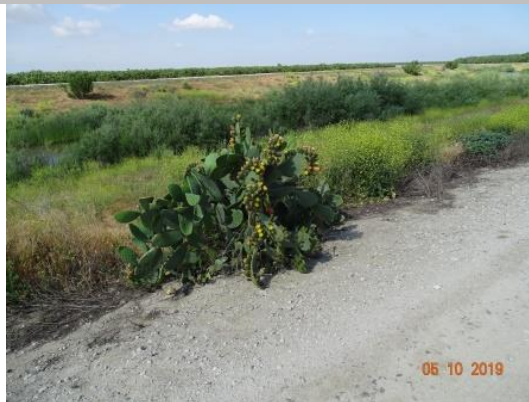
Photo 1 of 2 : SP_2019_NA0011_146_10_20190514_00041.jpg

LM Start	8.57	Rating **	U	Issue No.	10
LM End	8.57	Issue Type +	Ma	Location *	WS
Category	Earthen Levee			GPS Latitude/Longitude	
				Start	End
Item	Vegetation			36.972355 °	36.972355 °
				-120.220878 °	-120.220878 °
DWR ID	DWR_NA0011_05_f_2018_10				
Comment Code					
V2 : Remove the wild growth other than native grasses from the levee slopes.					
Inspector Comment					
Cactus growing on waterside slope.

Cactus growing on waterside shoulder. (Spring 2019)

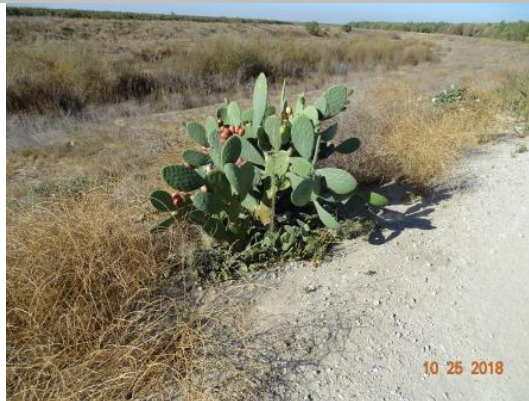
Photo 2 of 2 : SP_2019_NA0011_146_10_20190307_00003.jpg

LM Start	8.57	Rating **	U	Issue No.	10 (cont)	
LM End	8.57	Issue Type +	Ma	Location *	WS	
Category	Earthen Levee			GPS Latitude/Longitude		
				Start		End
Item	Vegetation			36.972355 °		36.972355 °
				-120.220878 °		-120.220878 °
DWR ID	DWR_NA0011_05_f_2018_10					
Comment Code						
V2 : Remove the wild growth other than native grasses from the levee slopes.						
Inspector Comment						
Cactus growing on waterside slope.

Cactus on waterside slope. (Fall 2018)

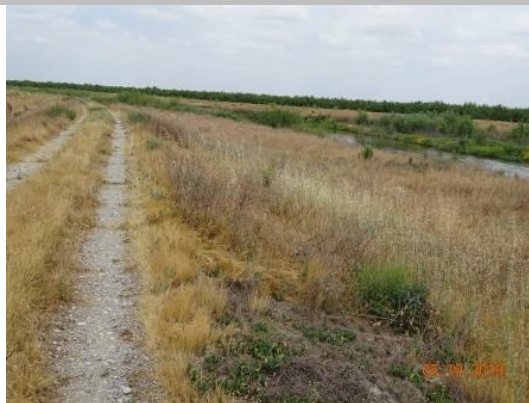
Photo 1 of 1 : SP_2019_NA0011_147_73_20190514_00058.jpg

LM Start	0.00	Rating **	U	Issue No.	73
LM End	0.96	Issue Type +	Ma	Location *	WS
Category	Earthen Levee			GPS Latitude/Longitude	
				Start	End
Item	Vegetation			36.976941 °	36.969349 °
				-120.367494 °	-120.354471 °
DWR ID	DWR_NA0011_06_s_2019_73				
Comment Code					
V1 : Control annual grass and weeds on the levee slopes and easements.					
Inspector Comment

View of waterside slope looking downstream. (Spring 2019)

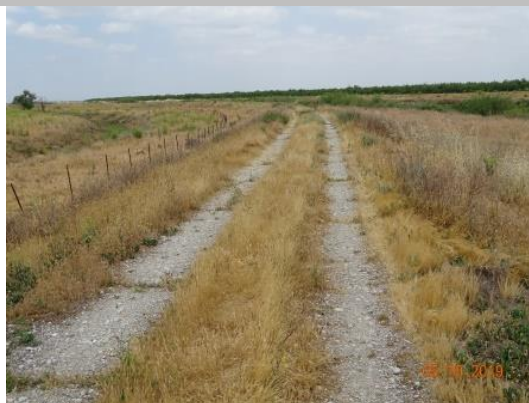
Photo 1 of 1 : SP_2019_NA0011_147_83_20190514_00057.jpg

LM Start	0.00	Rating **	U	Issue No.	83
LM End	0.96	Issue Type +	Ma	Location *	CR
Category	Earthen Levee			GPS Latitude/Longitude	
				Start	End
Item	Vegetation			36.976941 °	36.969349 °
				-120.367494 °	-120.354471 °
DWR ID	DWR_NA0011_06_s_2019_83				
Comment Code					
V9 : Keep the crown roadway free of vegetation.					
Inspector Comment

View of vegetation along levee crown looking downstream. (Spring 2019)

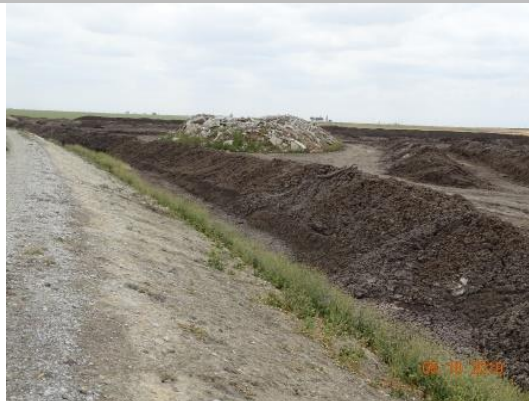
Photo 1 of 1 : SP_2019_NA0011_147_85_20190514_00059.jpg

LM Start	0.99	Rating **	U	Issue No.	85
LM End	1.07	Issue Type +	En	Location *	LS
Category	Earthen Levee			GPS Latitude/Longitude	
				Start	End
Item	Encroachments			36.968930 °	36.967985 °
				-120.354292 °	-120.353510 °
DWR ID	DWR_NA0011_06_s _ 2019_85				
Comment Code					
MA : Material					
Inspector Comment					
Soil material piled up on levee toe should be pushed back 10 feet from slope.

View of soil encroachment piled along levee toe. (Spring 2019)

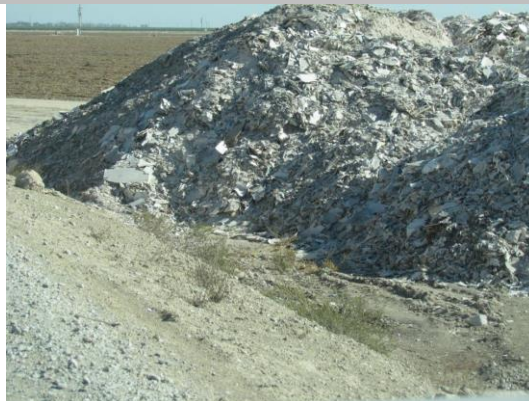
Photo 2 of 2 : SP_2019_NA0011_147_1_20190307_00002.jpg

LM Start	1.08	Rating **	U	Issue No.	1 (cont)
LM End	1.14	Issue Type +	En	Location *	LS

Recycle sheet rock piles within the landside easement.

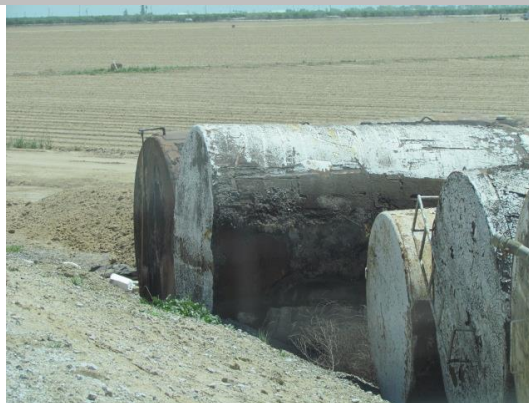
Photo 1 of 1 : SP_2019_NA0011_147_39_20190307_00021.jpg

LM Start	1.14	Rating **	U	Issue No.	39
LM End	1.17	Issue Type +	En	Location *	LS
Category	Earthen Levee			GPS Latitude/Longitude	
				Start	End
Item	Encroachments			36.967387 °	36.967270 °
				-120.352340 °	-120.351902 °
DWR ID	DWR_NA0011_06_s_2014_39				
Comment Code					
TA : Tank					
Inspector Comment					
Metal storage tanks are within the easement of the landward toe. Move them away from the easement.

Fresno River landside levee mile 1.16.

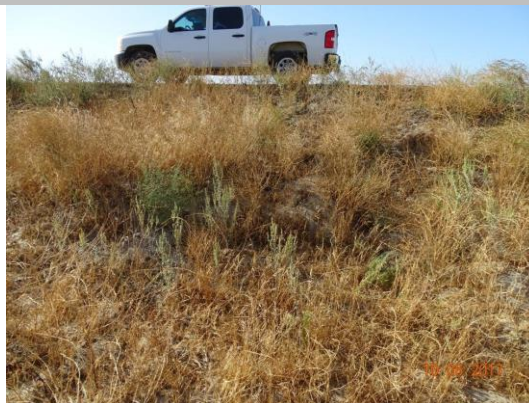
Photo 1 of 2 : SP_2019_NA0011_147_17_20190307_00006.jpg

LM Start	1.15	Rating **	U	Issue No.	17
LM End	1.15	Issue Type +	Ma	Location *	WS
Category	Earthen Levee			GPS Latitude/Longitude	
				Start	End
Item	Slope Stability			36.967334 °	36.967334 °
				-120.352154 °	-120.352154 °
DWR ID	DWR_NA0011_06_f_2017_17				
Comment Code					
S1 : Repair slope instability.					
Inspector Comment					
Observed slump possibly exacerbated by rodent activity. 20' long x 8' high x 18" deep into levee slope.

Observed slump possibly exacerbated by rodent activity. 20' long x 8' high x 18" deep into levee slope.

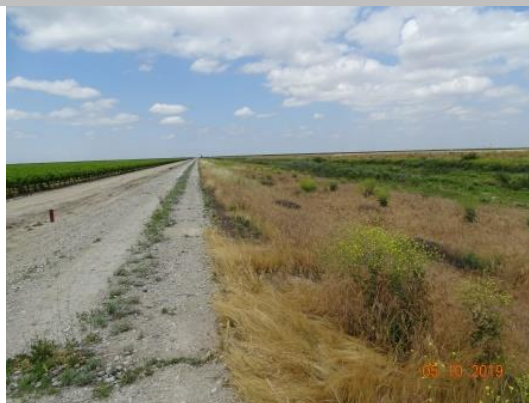
Photo 1 of 1 : SP_2019_NA0011_147_80_20190514_00060.jpg

LM Start	2.46	Rating **	U	Issue No.	80
LM End	3.48	Issue Type +	Ma	Location *	WS
Category	Earthen Levee			GPS Latitude/Longitude	
				Start	End
Item	Vegetation			36.967233 °	36.967369 °
				-120.328568 °	-120.310239 °
DWR ID	DWR_NA0011_06_s_2019_80				
Comment Code					
V1 : Control annual grass and weeds on the levee slopes and easements.					
Inspector Comment

View of vegetation on waterside slope looking downstream. (Spring 2019)

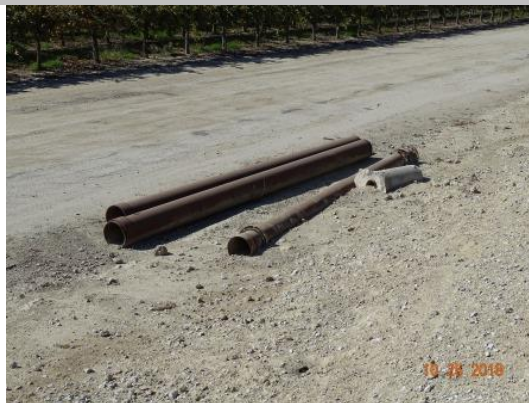
Photo 1 of 1 : SP_2019_NA0011_147_24_20190307_00012.jpg

LM Start	3.39	Rating **	M	Issue No.	24
LM End	3.39	Issue Type +	En	Location *	LS
Category	Earthen Levee			GPS Latitude/Longitude	
				Start	End
Item	Encroachments			36.967378 °	36.967378 °
				-120.311737 °	-120.311737 °
DWR ID	DWR_NA0011_06_f_2017_24				
Comment Code					
EQ : Equipment					
Inspector Comment					
Remove large pipe sections from toe of levee.

pipe segments left at levee toe. (Fall 2018)

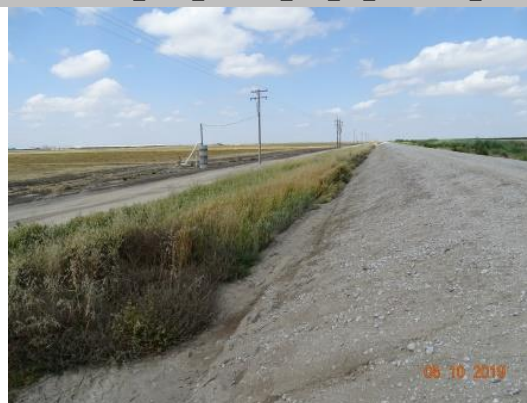
Photo 1 of 1 : SP_2019_NA0011_147_77_20190514_00061.jpg

LM Start	3.99	Rating **	U	Issue No.	77
LM End	5.48	Issue Type +	En	Location *	LS
Category	Earthen Levee			GPS Latitude/Longitude	
				Start	End
Item	Encroachments			36.967439 °	36.967487 °
				-120.300974 °	-120.273999 °
DWR ID	DWR_NA0011_06_s_2019_77				
Comment Code					
CR : Crops					
Inspector Comment					
Landowner has planted wheat along the landside toe.

Wheat planted in the landside toe. (Spring 2019)

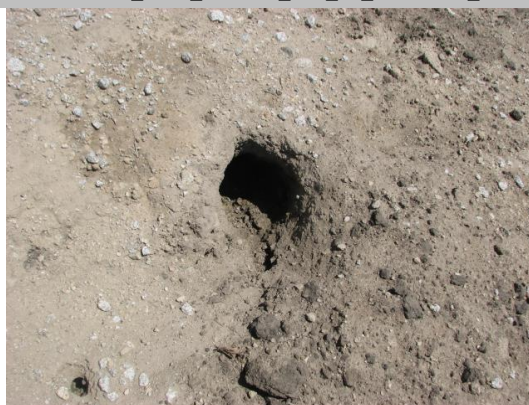
Photo 1 of 1 : SP_2019_NA0011_147_53_20190307_00029.jpg

LM Start	5.44	Rating **	U	Issue No.	53
LM End	5.44	Issue Type +	Ma	Location *	LS
Category	Earthen Levee		GPS Latitude/Longitude		
			Start	End	
Item	Animal Control		36.967514 °	36.967514 °	
			-120.274810 °	-120.274810 °	
DWR ID	DWR_NA0011_06_s_2018_53				
Comment Code					
A3 : No rodents visible, but rodent burrows visible; need to backfill and compact or grout burrows.					
Inspector Comment					
Control rodents within this section.

Looking at typical rodent hole on landward slope. (Spring 2018)

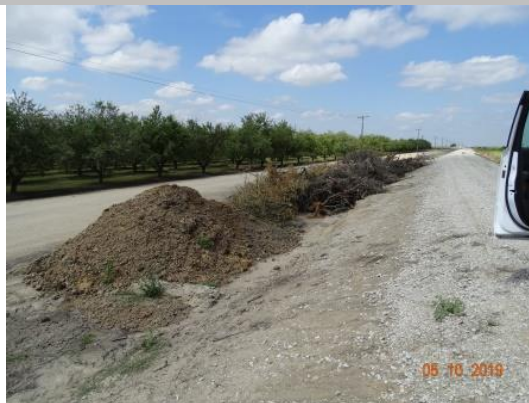
Photo 1 of 1 : SP_2019_NA0011_147_38_20190514_00062.jpg

LM Start	6.09	Rating **	U	Issue No.	38
LM End	6.13	Issue Type +	En	Location *	LS
Category	Earthen Levee			GPS Latitude/Longitude	
				Start	End
Item	Encroachments			36.967482 °	36.967511 °
				-120.262984 °	-120.262342 °
DWR ID	DWR_NA0011_06_f_2017_38				
Comment Code					
TR : Tree or limb					
Inspector Comment					
Remove downed trees and associated debris pile from levee toe.

View of debris pile and pruning piles along landside toe. (Spring 2019)

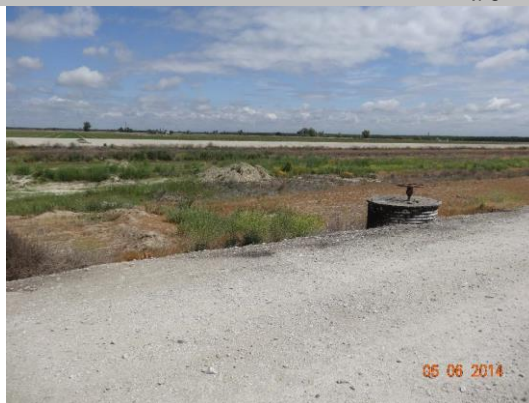
Photo 1 of 3 : UCIP_SP_2019_52854_64570.jpg

LM Start	6.17	Rating **	M	Issue No.	86
LM End	6.17	Issue Type +	En	Location *	
Category	Supplemental			GPS Latitude/Longitude	
				Start	End
Item	DWR UCIP Field Study			36.967568 °	36.967568 °
				-120.261594 °	-120.261594 °
DWR ID	21531				
Comment Code					
Inspector Comment					
FS_ID:52854 DS_ID:21531 EP_NO: N/A Repair Type: Non-Urgent Crossing Status: Found UCIP Comments: 05/06/2014 Need to contact owner. Recommend removing sediment built up on landward side. (DWR UCIP - O. Magana) FIELD_STRUCT_DESC: 48-inch corrugated metal gravity drainage pipe through the levee, 11.5 feet below the crown. Slide gate on the waterside (WS) shoulder. Headwall and wing wall on each end. Flap gate on the WS end. [Additional Reference(s): DWR Levee Log, 2005]. FS Date: 5/6/2014

View of waterward side.

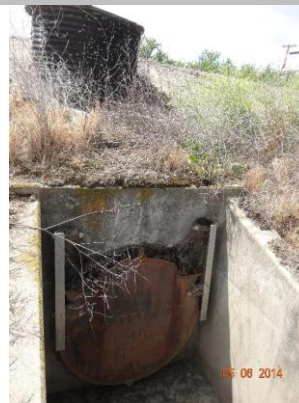
Photo 2 of 3 : UCIP_SP_2019_52854_64573.jpg

LM Start	6.17	Rating **	M	Issue No.	86 (cont)	
LM End	6.17	Issue Type +	En	Location *		
Category	Supplemental			GPS Latitude/Longitude		
				Start	End	
Item	DWR UCIP Field Study			36.967568 °	36.967568 °	
				-120.261594 °	-120.261594 °	
DWR ID	21531					
Comment Code						
Inspector Comment						
FS_ID:52854						
DS_ID:21531						
EP_NO: N/A						
Repair Type: Non-Urgent						
Crossing Status: Found						
UCIP Comments: 05/06/2014 Need to contact owner. Recommend removing sediment built up on landward side. (DWR UCIP - O. Magana)						
FIELD_STRUCT_DESC: 48-inch corrugated metal gravity drainage pipe through the levee, 11.5 feet below the crown. Slide gate on the waterside (WS) shoulder. Headwall and wing wall on each end. Flap gate on the WS end. [Additional Reference(s): DWR Levee Log, 2005].						
FS Date: 5/6/2014

Flap gate, concrete headwall, and standpipe on waterward side.

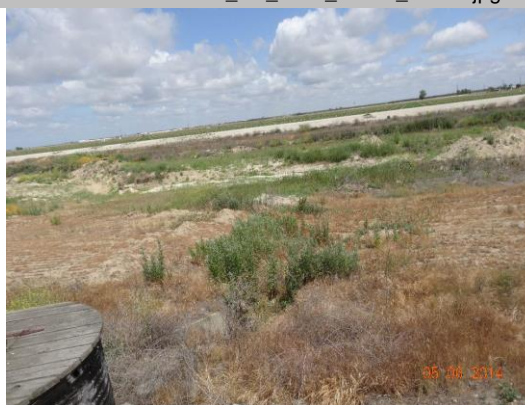
Photo 3 of 3 : UCIP_SP_2019_52854_64572.jpg

Overview of channel at crossing.

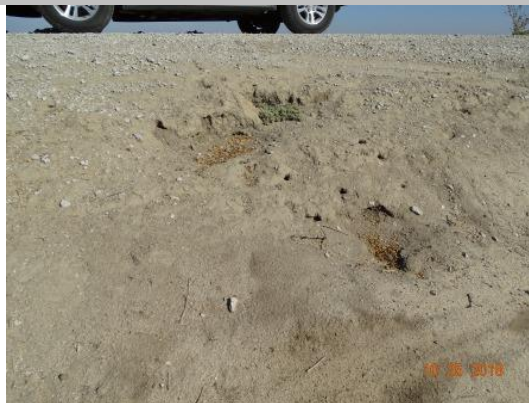
Photo 1 of 1 : SP_2019_NA0011_147_58_20190307_00032.jpg

LM Start	6.29	Rating **	M	Issue No.	58
LM End	6.29	Issue Type +	Ma	Location *	LS
Category	Earthen Levee			GPS Latitude/Longitude	
				Start	End
Item	Erosion / Bank Caving			36.967750 °	36.967750 °
				-120.259385 °	-120.259385 °
DWR ID	DWR_NA0011_06_f_2018_58				
Comment Code					
E2 : Schedule repair of erosion site prior to the next inspection.					
Inspector Comment

minor erosion in landside slope. (Fall 2018)

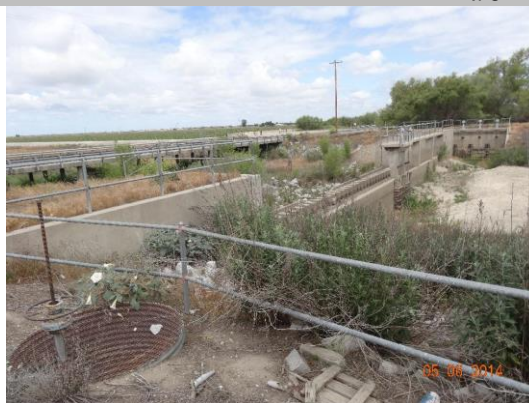
Photo 1 of 3 : UCIP_SP_2019_52855_69722.jpg

Comment Code					
Inspector Comment					
FS_ID:52855 DS_ID:21532 EP_NO: N/A Repair Type: Non-Urgent Crossing Status: Found UCIP Comments: 7/14/2016 Same as previous inspection. Need to coordinate with owner. Need permit number authorizing work. (DWR UCIP - omagana)5/06/2014 Need to contact owner. Crossing on landward side appears to be modified--no headwall found on landward end. (DWR UCIP - omagana) FIELD_STRUCT_DESC: 30-inch corrugated metal pipe (CMP) of an unknown purpose through the levee, 12 feet below the crown. Slide gate in a 5-foot CMP riser on the waterside (WS) shoulder. Headwall and wing wall on the WS end. Concrete headwall on the landside (LS) end. [Additional Reference(s): DWR Levee Log, 2005]. FS Date: 7/14/2016

View of WS.

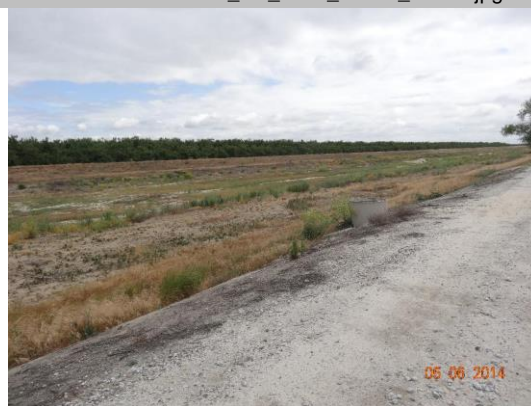
Photo 1 of 3 : UCIP_SP_2019_52860_64585.jpg

Comment Code					
Inspector Comment					
FS_ID:52860 DS_ID:21587 EP_NO: 13837 Repair Type: Non-Urgent Crossing Status: Found UCIP Comments: 05/06/2014 Need to contact owner. Dense vegetation limits the inspector's visibility to identify signs of pipe failure (leaks) along the waterward slope. Recommend removing vegetation along pipe alignment to conduct proper inspection of structure and appurtenances. (DWR UCIP - O. Magana) FIELD_STRUCT_DESC: 12-inch reinforced concrete gravity irrigation pipe through the levee, 7.5 feet below the floodplain. The pipe extends to a 27-inch concrete standpipe in the overflow area and through the levee section to a 30-inch standpipe on the landside (LS). Positive closure device with walkway on the waterside (WS). (Plans to install a 20-inch concrete pipe through the levee for irrigation authorized under Permit No. 13837, 1984 - Averill Ranch). FS Date: 5/6/2014

View of waterward side.

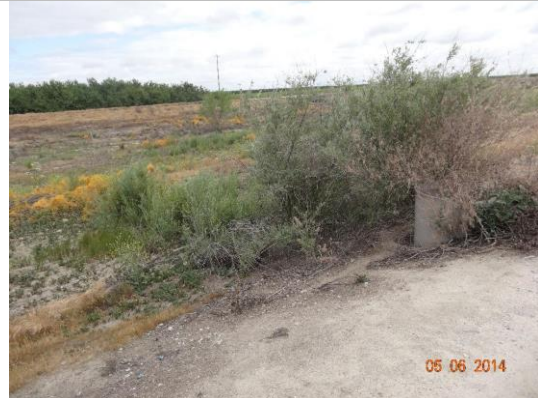
Photo 1 of 3 : UCIP_SP_2019_52861_64590.jpg

Comment Code					
Inspector Comment					
FS_ID:52861 DS_ID:21588 EP_NO: 13856 Repair Type: Non-Urgent Crossing Status: Found UCIP Comments: 05/06/2014 Need to contact owner. Dense vegetation limits the inspector's visibility to identify signs of pipe failure (leaks) along the waterward slope. Recommend removing vegetation along pipe alignment to conduct proper inspection of structure and appurtenances. (DWR UCIP - O. Magana) FIELD_STRUCT_DESC: 12-inch reinforced concrete gravity irrigation pipe through the levee, approximately 4 feet below the crown. The pipe extends from a 24-inch standpipe in the overflow area and through the levee section to a 36-inch standpipe on the landside (LS). Positive closure device with a walkway on the waterside (WS). (Plans to install a 20-inch concrete gravity irrigation pipe through the levee authorized under Permit No. 13856, 1984 - Averill Ranch). FS Date: 5/6/2014

View of waterward side.

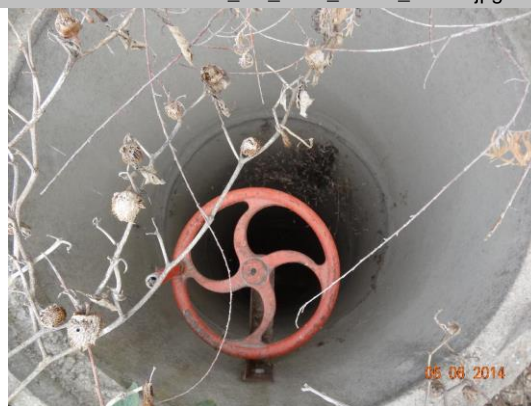
Photo 2 of 3 : UCIP_SP_2019_52861_64589.jpg

Inside view of standpipe located on waterward side.

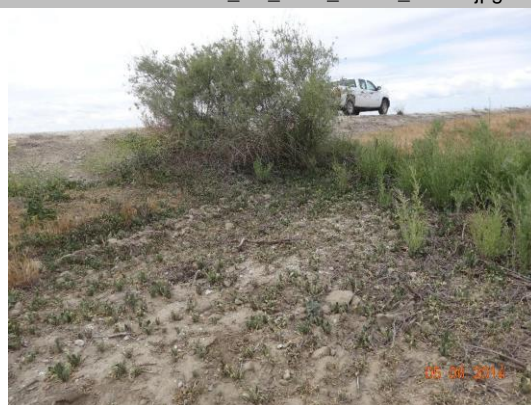
Photo 3 of 3 : UCIP_SP_2019_52861_64594.jpg

View of waterward slope.

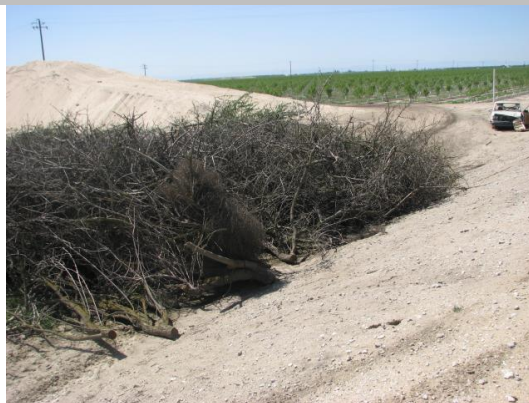
Photo 1 of 2 : SP_2019_NA0011_147_52_20190307_00027.jpg

LM Start	7.49	Rating **	U	Issue No.	52
LM End	7.49	Issue Type +	En	Location *	LS
Category	Earthen Levee			GPS Latitude/Longitude	
				Start	End
Item	Encroachments			36.968886 °	36.968886 °
				-120.237967 °	-120.237967 °
DWR ID	DWR_NA0011_06_s_2018_52				
Comment Code					
PR : Prunings					
Inspector Comment					
Farmer is piling large tree limbs and branches at landward toe.

Looking upstream at prunings at landward toe. (Spring 2018)

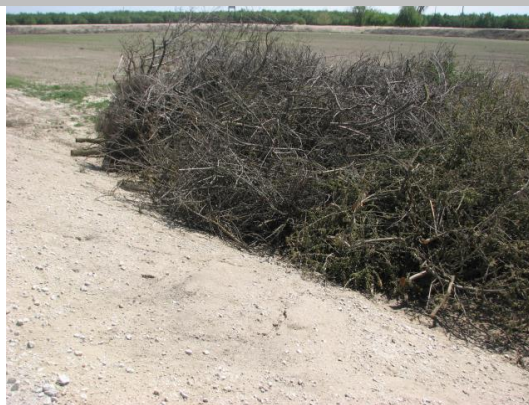
Photo 2 of 2 : SP_2019_NA0011_147_52_20190307_00028.jpg

LM Start	7.49	Rating **	U	Issue No.	52 (cont)
LM End	7.49	Issue Type +	En	Location *	LS

Looking downstream at prunings at landward toe. (Spring 2018)

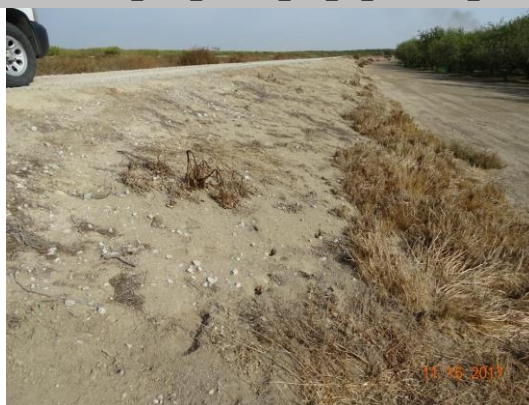
Photo 1 of 1 : SP_2019_NA0011_147_47_20190307_00023.jpg

LM Start	7.71	Rating **	M	Issue No.	47
LM End	8.52	Issue Type +	Ma	Location *	LS
Category	Earthen Levee			GPS Latitude/Longitude	
				Start	End
Item	Animal Control			36.969600 °	36.971509 °
				-120.234229 °	-120.220438 °
DWR ID	DWR_NA0011_06_f_2017_47				
Comment Code					
A3 : No rodents visible, but rodent burrows visible; need to backfill and compact or grout burrows.					
Inspector Comment

Bait traps should be maintained and rodent holes should be backfilled.

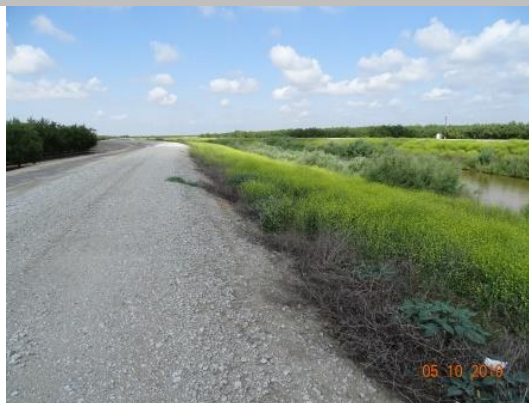
Photo 1 of 1 : SP_2019_NA0011_147_16_20190514_00063.jpg

LM Start	7.95	Rating **	U	Issue No.	16
LM End	9.01	Issue Type +	Ma	Location *	WS
Category	Earthen Levee			GPS Latitude/Longitude	
				Start	End
Item	Vegetation			36.971498 °	36.972571 °
				-120.230503 °	-120.211912 °
DWR ID	DWR_NA0011_06_s_2019_16				
Comment Code					
V1 : Control annual grass and weeds on the levee slopes and easements.					
Inspector Comment

View along the waterside slope looking downstream. (Spring 2019)

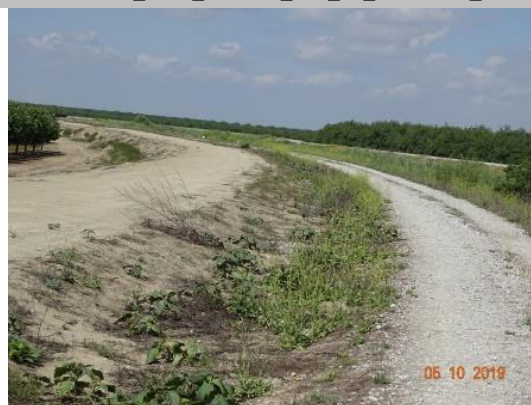
Photo 1 of 1 : SP_2019_NA0011_147_45_20190514_00065.jpg

LM Start	8.01	Rating **	M	Issue No.	45
LM End	8.39	Issue Type +	Ma	Location *	LS
Category	Earthen Levee			GPS Latitude/Longitude	
				Start	End
Item	Vegetation			36.971629 °	36.972212 °
				-120.229491 °	-120.222607 °
DWR ID	DWR_NA0011_06_s_2019_45				
Comment Code					
V1 : Control annual grass and weeds on the levee slopes and easements.					
Inspector Comment

View of the landside slope looking downstream. (Spring 2019)

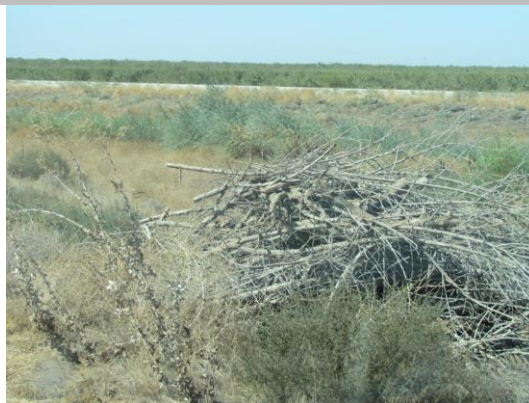
Photo 2 of 2 : SP_2019_NA0011_147_36_20190307_00019.jpg

LM Start	8.03	Rating **	M	Issue No.	36 (cont)	
LM End	8.03	Issue Type +	Ma	Location *	WS	
Category	Earthen Levee			GPS Latitude/Longitude		
				Start		End
Item	Encroachments			36.971582 °	36.971582 °	
				-120.229180 °	-120.229180 °	
DWR ID	DWR_NA0011_06_f_2015_36					
Comment Code						
TR : Tree or limb						
Inspector Comment						
The dead tree has been removed from blocking the roadway but still need to be removed from the levee section.

Fresno River levee mile 8.03 waterside slope and shoulder.

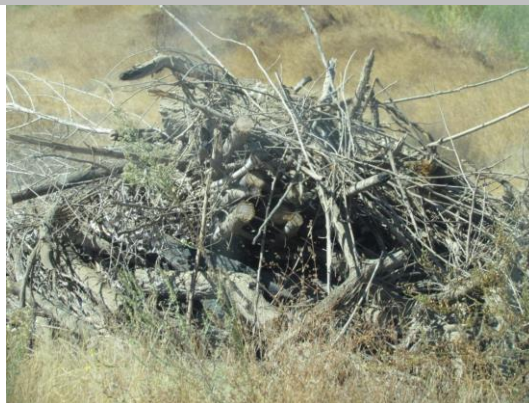
Photo 1 of 1 : SP_2019_NA0011_147_31_20190307_00015.jpg

LM Start	8.09	Rating **	U	Issue No.	31
LM End	8.09	Issue Type +	Ma	Location *	WS
Category	Earthen Levee			GPS Latitude/Longitude	
				Start	End
Item	Encroachments			36.971692 °	36.971692 °
				-120.227957 °	-120.227957 °
DWR ID	DWR_NA0011_06_f_2015_31				
Comment Code					
TR : Tree or limb					
Inspector Comment					
Remove the dead tree off the slope and shoulder, this has been reported in the last two inspections.

Fresno River levee mile 8.09.
